825 Site Visit - Aug 19, 2021

Vapor Intrusion Assessment 825 Stewart Drive, Sunnyvale

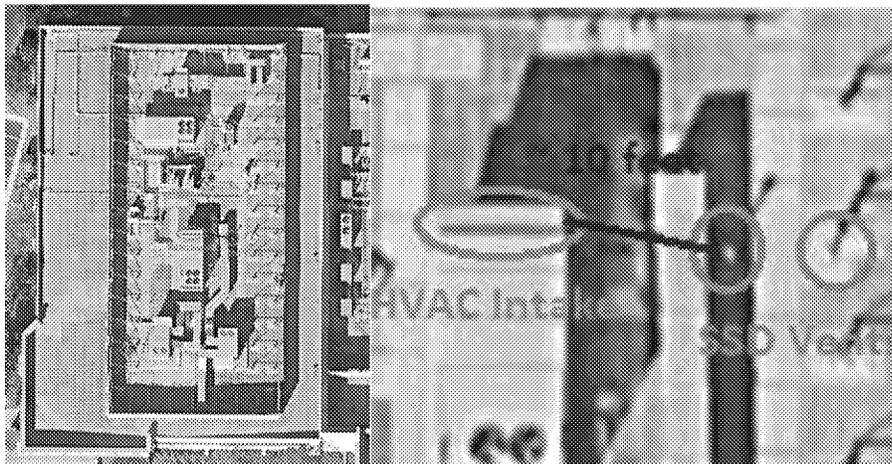
West Building

- Significant, visible slab cracks, gaps and penetrations had been sealed.
- There was positive pressure between the lobby and outside of approximately 1.5 pascal during the visit.
- The elevator pit and penetrations appear to be sealed from the subsurface. The elevator is a typical piston type low rise elevator. The piston housing remains a potential pathway for vapor entry, as it penetrates deep into the subsurface (typically these are twenty feet or more deep).
- The SSD vents on the roof are not significantly elevated above the roof (~ 3 feet) and are sheltered from wind.
- A main HVAC intake is approximately 10-feet from the western SSD vent. It is recommended that the vent stacks be reconfigured to avoid vapor intake from the HVAC.

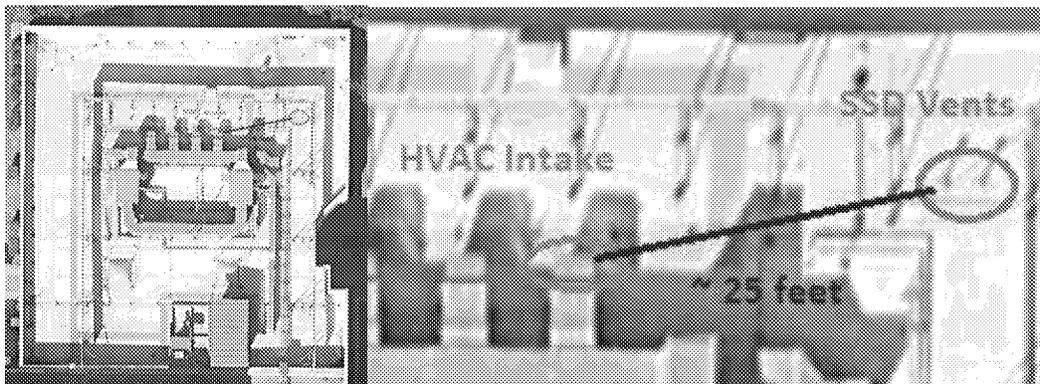
North Building

- There was positive pressure between the rear hall and the outside of 4 pascals.
- Several subslab ports could not be located.
- The SSD vents on the roof are approximately 25 feet from the nearest HVAC intake and they were relatively unobstructed by HVAC and roof structures.
