Report on Groundwater Observation Wells

**Stone & Webster Civil &
Transportation Services, Inc.**

April 1990

REPORT ON
GROUNDWATER OBSERVATION WELLS
FOR THE
INSPECTIONAL SERVICES DEPARTMENT
OF THE
CITY OF BOSTON
AND
THE GROUNDWATER TRUST

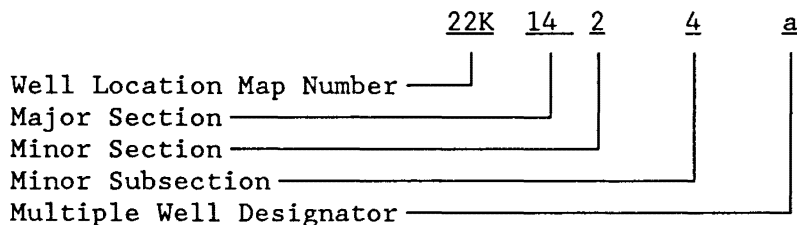
To facilitate development and use of the database, a unique number was assigned to each well. This number was obtained by overlaying a transparent numbering template over the area of the Well Location Map (see Figure 2). Assigned numbers took the form:

- used if more than 1 well is found in a particular minor subsection

This numbering system was developed to give the observation wells surveyed a geographic identity. This identity was helpful in developing the observation well database, and will greatly facilitate its use. This number along with the well source and previous well number were entered into the database

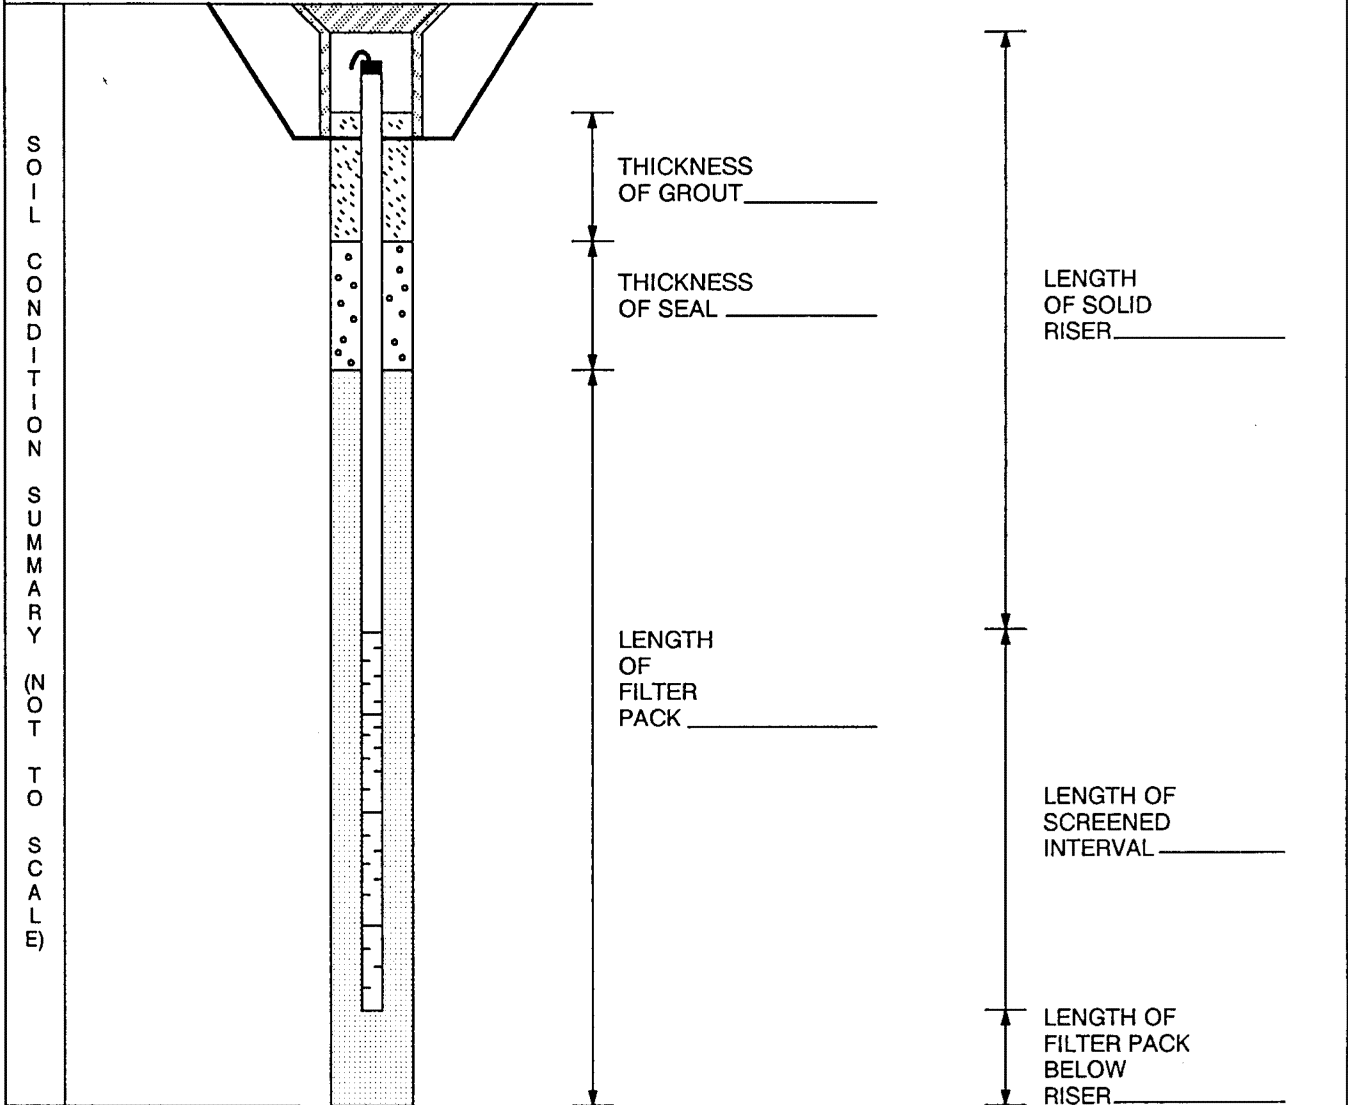
WELL DATA

Method of Drilling
Diameter of Borehole
Depth of Borehole
Riser Material
Riser Diameter
Screen Gauge
Type of Filter Sand
Elev./Depth to Well Point
Elev./Depth to Groundwater
